Organoclay-filled reactive core mat DNAPL remedial barrier proves successful

Koppers Wood Treatment Facility

Guthrie, KY

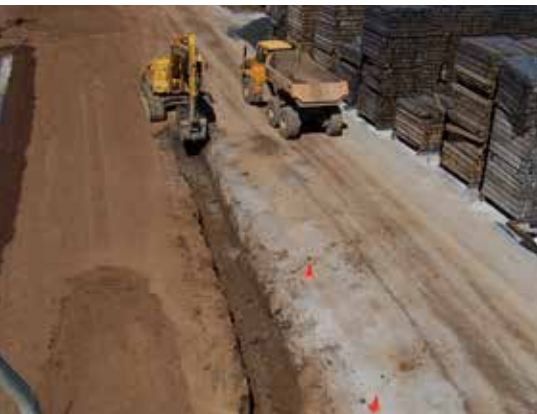
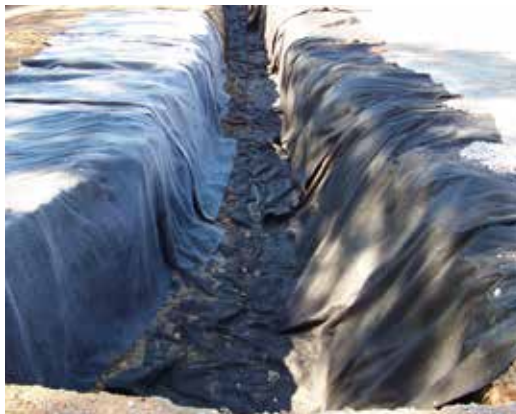
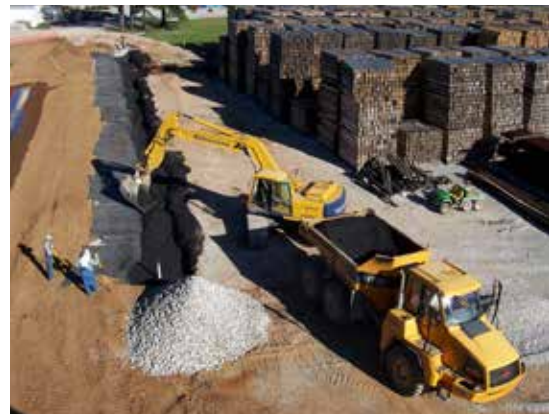
The approximate 200-foot long passive DNAPL barrier trench was designed with 4,500 square feet of REACTIVE CORE MAT® (RCM) filled with ORGANOCLAY® along the down-gradient wall. The RCM was added as an added precaution to adsorb DNAPL droplets that may be too small to gravity settle before crossing the trench. The trench therefore uses a combination of gravity separation and sorption to intercept DNAPL. A high-density polyethylene pipe was installed along the bottom of the trench to facilitate removal

of settled DNAPL. Construction of the remedial activities was performed in the fall of 2004. The trench was excavated by backhoe utilizing open trench technique. The 15' wide panels of RCM were unrolled along the downgradient wall with several feet of extra panel flapped back from the top of the trench. After the trench was filled with the collection pipe and coke, this RCM was then draped over the top of the trench and covered with drainage stone.
