Lining of the Border Checkpoint Embankment in Zosin, Poland

Extension of the border checkpoint for cars in Zosin

Eastern borderline of the European Union (Poland – Ukraine) in Zosin, Horodło commune, Poland

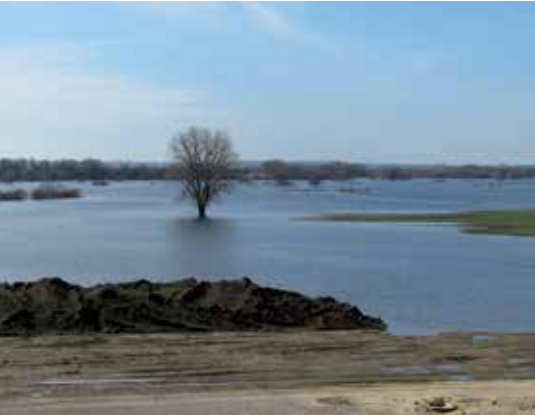
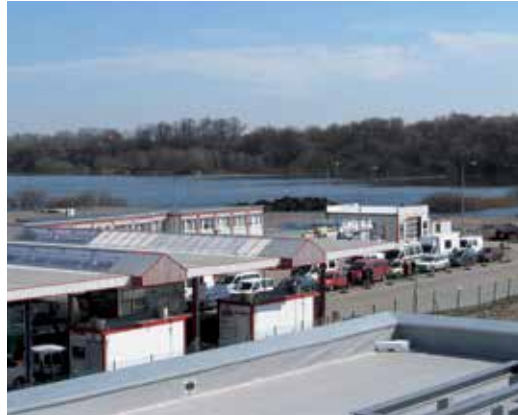
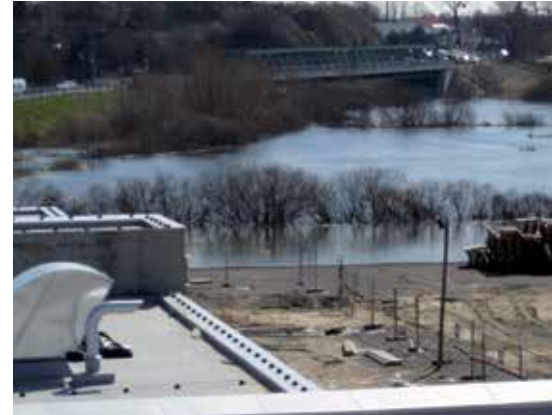
The contractor sought a simple, reliable and proven lining solution. CETCO proposed the installation of BENTOMAT geosynthetic clay liner. Due to the steep inclination of embankment's slopes, a reinforced Trinter geocomposite was used to increase stability of the soil cover over GCL. Trinter provides superficial reinforcement and erosion control, supporting the development of vegetative cover at its early stage.
