ORGANOCLAY Permeable Reactive Barrier Utilized to Control NAPL Contamination

Bay Project – Union Pacific Railroad
Engineer: Ch2M Hill
Contractor: Ch2M Hill Construction
Subcontractor: DeWind Dewatering

Escanaba, MI

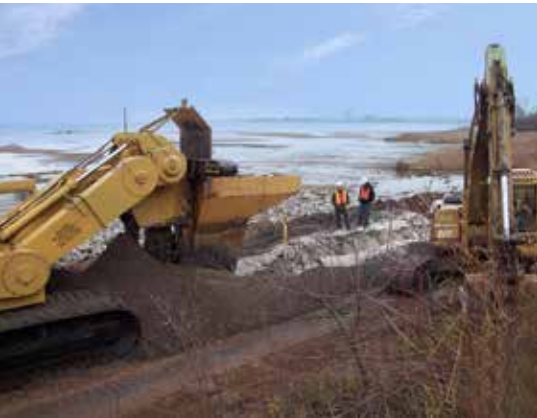
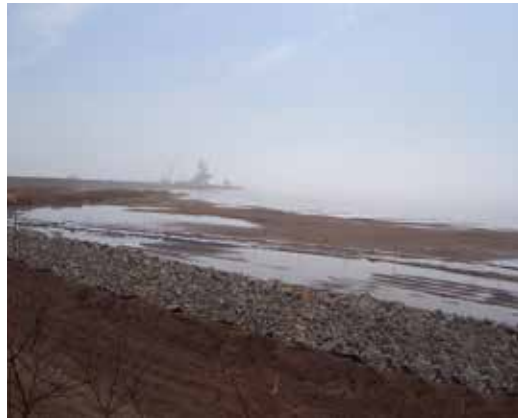
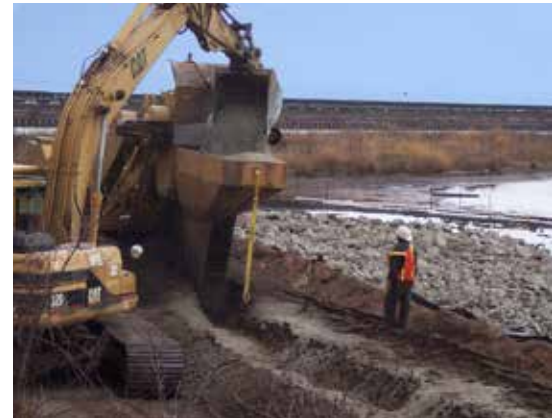
Approximately 15 ft (5 m) up gradient of the RCM a permeable reactive barrier wall was installed. One part organoclay was mixed with 3 parts of ¼ inch (6 mm) pea gravel by volume in a stockpile. A continuous trenching machine placed the organoclay-gravel mix in an 18 inch (45 cm) wide by 10 ft (3 m) deep by 240 ft (80 m) long trench. The organoclay PRB was completed in one day.

To stop the pollution from spreading through the bay and into Lake Michigan, an interim measure was taken which consisted of installing a permeable reactive barrier (PRB) containing ORGANOCLAY® media and CETCO REACTIVE CORE MAT® (RCM) along the affected stretch of beach and a permeable reactive wall behind the RCM.

The sheen dissipated from the fresh water bay as soon as the RCM and PRB was installed and brought online. The installed cost for mobilization/demobilization, RCM installation, PRB installation, site restoration, and waste disposal was approximately \$220,000. The organoclay RCM and PRB have worked successfully for three years. Piezometers were installed upstream and downstream of the PRB. The piezometers indicate that there is no mounding of the upstream groundwater. There is DNAPL present the central upstream piezometer, but no DNAPL in the respective downstream piezometer. Also, no sheen has been observed emanating from the RCM.
