REACTIVE CORE MAT installed as NAPL control remedy at Vermont superfund site

Pine Street Canal Superfund Site

Burlington, Vermont, U.S.A.

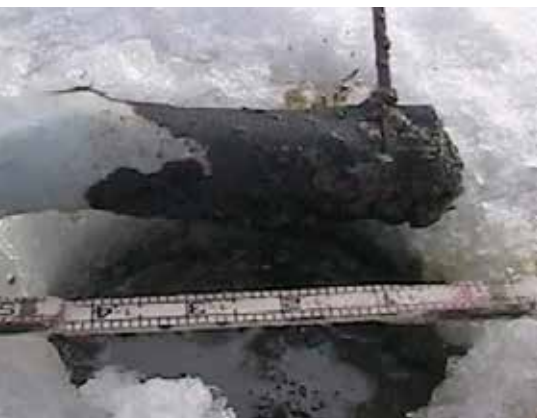
Image left to right: Left - Shows measurable DNAPL on the sand cap surface (Winter 2003/2004). Middle - Surface sheen that was observed after the sand cap installation (2005). Right - ORGANOCLAY® REACTIVE CORE MAT® being deployed from a barge. Reactive Core Mat® was deployed in multiple layers in some areas.

Nonaqueous-phase liquid (NAPL) was detected on a limited portion of the completed sand cap at the Pine Street Canal Superfund Site. In addition, sheen was observed on the surface of the canal water. Investigations by the active cap design engineer, ARCADIS, revealed that NAPL had migrated through the sand cap due to consolidation and the effects of vertical hydraulic gradients. In 2006, ARCADIS was retained to prepare an Action Plan for development of a revised remedy to control NAPL migration into the Canal.

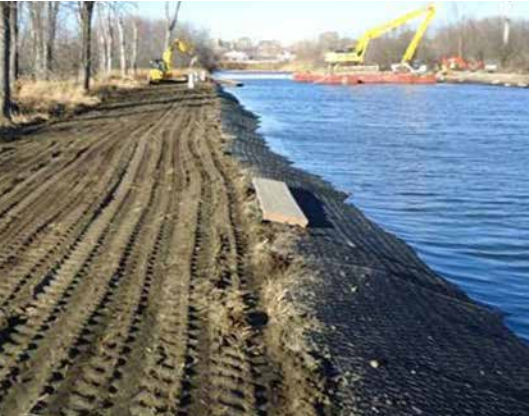
Finished cap.

In 2010, 165,000 square feet of ORGANOCLAY® REACTIVE CORE MAT® was successfully deployed as an amendment to a portion of the existing sand cap. Historical flooding occurred at the site in Spring 2011. The Final EPA inspection was conducted in August 2011. Since installation, no NAPL seeps have been observed through the amended cap, and all components are stable following flooding.
